# The Extension of the Pointe Noire Breakwater – Congo

## Summary

The design of the extension of the Pointe Noire breakwater and the optimisation of the crest design by physical model testing are described in this paper. A hybrid construction with interlocking concrete armour units on the slopes in combination with rock armour on the crest was applied for this structure. The model tests demonstrated the advantages of this approach for low crested breakwaters. Following the design of the Pointe-Noire breakwater additional systematic research was conducted based on the stability of Xbloc armour on low crested breakwaters. Based on this research an increase in Xbloc armour unit weight of 50% for structures with relative freeboard of  $R_c/H_s < +1.0$  and of 100% for relative freeboard  $R_c/H_s < +0.5$  is recommended. The results of project specific 3D model tests have been applied successfully to improve the construction methodology of the Pointe Noire breakwater in order to cope with the local conditions including rapid sedimentation of the structure and to manage weather downtime during construction due to the swell conditions.

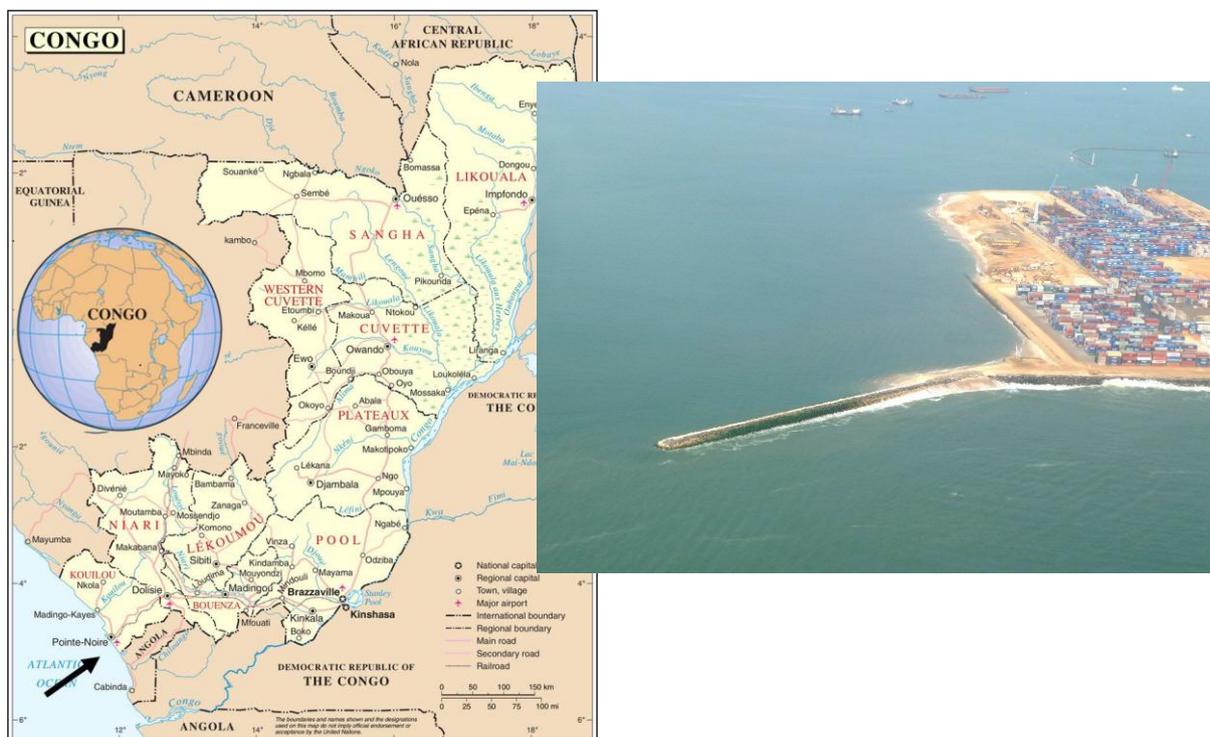
Figure 1: Site location and completed breakwater extension Pointe-Noire – Congo.

Le Port Autonome de Pointe-Noire is the largest sea port in Congo (Figure 1) and has been operational since the 1930's. The port infrastructure has been developed across various projects over the years and currently several projects are under construction to further upgrade the port facilities. In 2009, a tender was awarded to Royal Boskalis Westminster nv for the extension of the existing breakwater by 300m in order to reduce sediment transport into the port basin.

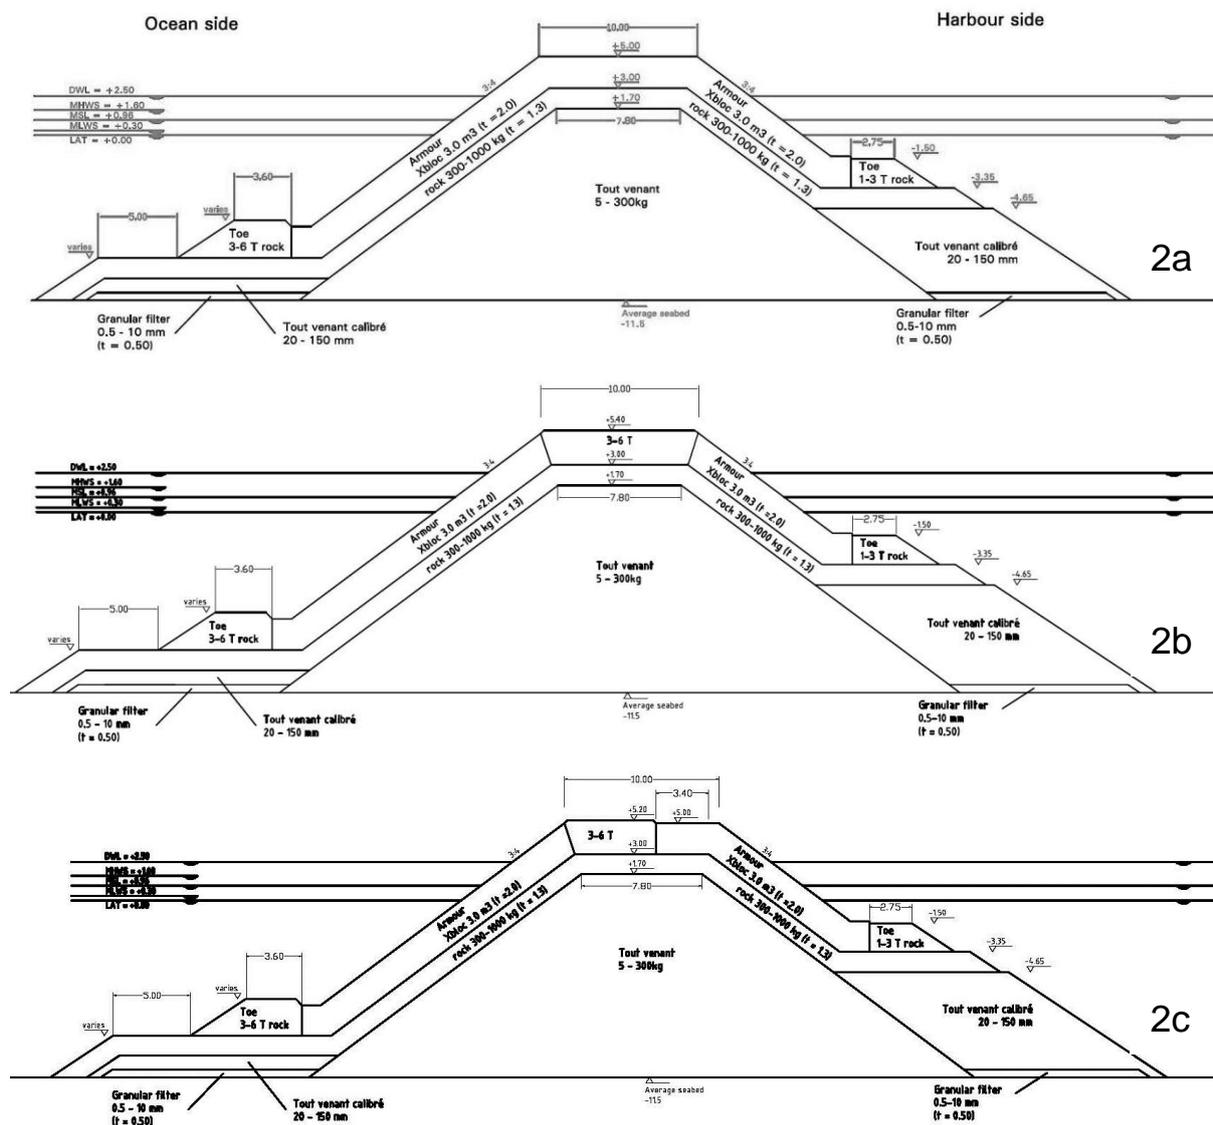
Figure 2: Successively tested cross sections; Initial cross section with Xbloc crest armour (2a); crest with 3-6 tonnes rock armour (2b); crest with 3-6 tonnes rock and Xbloc crest armour (2c).

In order to improve the stability of the Xbloc units in the uppermost part of the slope, and to increase the crest stability without increasing the Xbloc size, it was decided to place 3-6 tonnes rock armour on

the crest (Figure 2b). The rock armour was envisaged to behave as a locking mechanism for the Xblocs in the top rows, while also allowing better accommodation under potential settlement, thereby improving the support of the Xbloc units near the crest. Rock armour gains its stability mainly from its own weight and not by interlocking with neighbouring units. Contrary to stability mechanisms of interlocking units, the stability of rock increases on gentle slopes. The use of rock is therefore believed to be a better solution for crest armoring, especially in cases where the crest is relatively low.

A stable solution for the breakwater crest was found by placing Xbloc armour on the rear side of the crest resulting in the locking in of the armour rock on the seaward side of the crest (Figure 2c). Two rows of Xblocs were placed on the harbour side (lee) of the crest. The layer thickness of the rock

armour was reduced from 2.4 to 2.2 m and special attention was paid to the installation of the 3-6 tonnes rock on the crest to create a smoother surface in this area.

3D model tests were conducted in March 2011 in the HR Wallingford laboratory to verify the stability of the breakwater head. The armour on the breakwater head consisted of 4m<sup>3</sup> Xbloc units. Findings of the 2D model tests were incorporated into the design. The Xbloc armour on the crest was partly replaced by a 2.2m thick layer of 3-6 tonnes rock (Figure 2c).

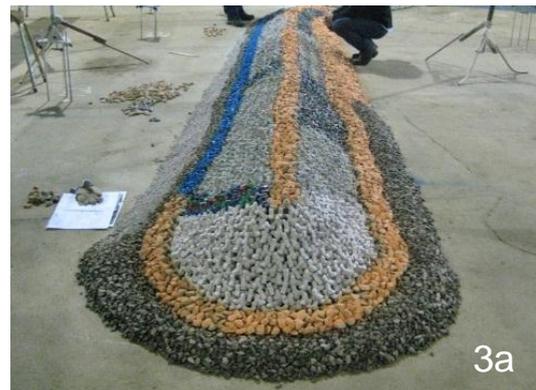
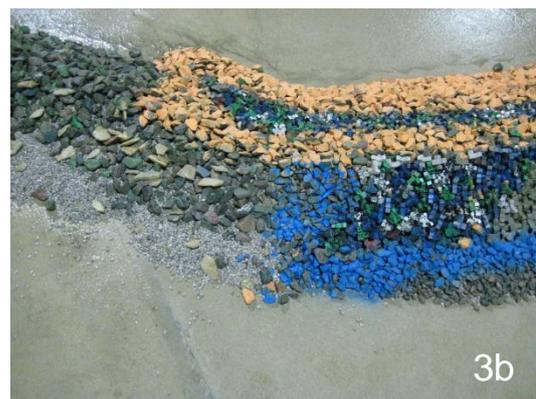
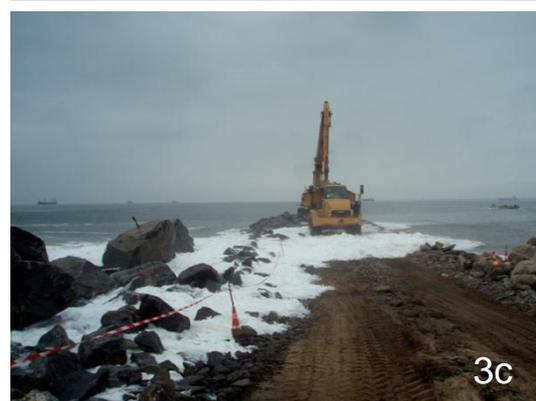
Figure 3: Setup 3D model (3a); The transition after 3D model testing (3b) and overtopping at the transition during construction (3c).

The 3D model test provided further insight into the design of the connection of the existing breakwater to the new breakwater. The transition proved to be on a location where there was wave focussing. As a result this section was frequently overtopped and the 1-3 tonnes rock used in the lee slope armouring was found to be unstable. Ultimately the displacement of armour rock to the lee resulted in undermining of the crest at the transition. The Xbloc armour in the vicinity of the transition was not affected, however, it showed that the design of the transition had to be improved. Figure 3 shows the effect of wave overtopping due to wave focussing along the transition in the 3D model tests and during construction.

In the final design, the start point for the Xbloc armour layer was shifted seaward, away from the transition. The rock size of the rear armour was increased from 1-3 tonnes to 3-6 tonnes. The armour layer of the front slope at the transition from the old to the new breakwater was constructed with 6-8 tonnes rock.

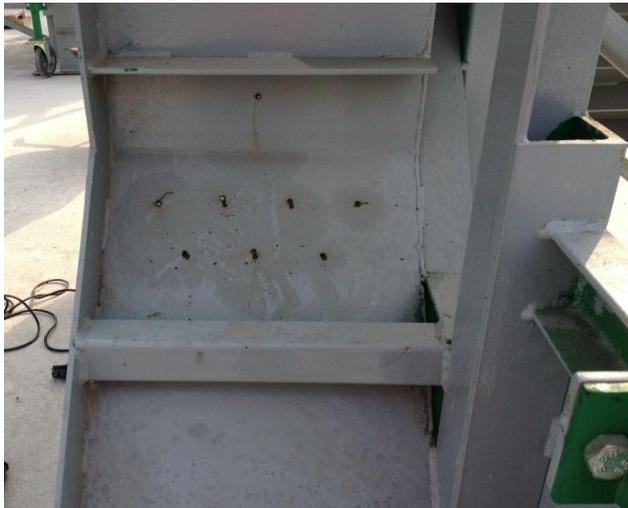
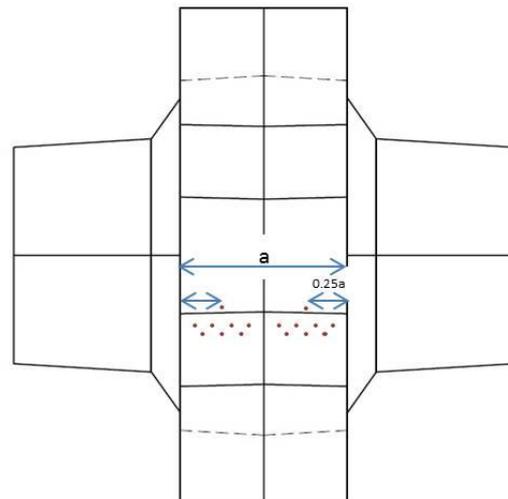
During the initial stages of production some crack development was encountered in the lower inside corner of the Xblocs. Depending on the concrete mix design, such cracks may develop near angles in the formwork. In order to reduce the development of cracks, a series of holes were drilled in the formwork around the lower inside corner. By drilling these holes, excess concrete paste and water is able to flow out of the mould and are not trapped in the corner. After drilling of these holes no further cracks were encountered. The holes had a diameter of 6mm and were drilled as shown in Figure 4. It is expected that this solution would also be applicable to crack reduction in corners of similar shaped units.

Figure 4: Pattern of holes in the formwork

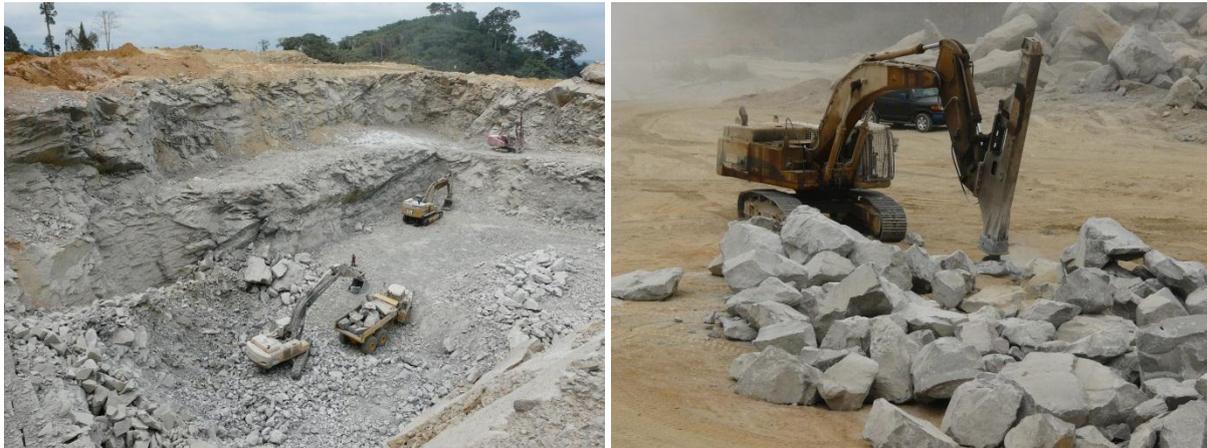
Figure 5: Quarry operations

Rock material was required as filter, core and underlayer for the breakwater and as aggregates for the Xbloc production. The rock for the structure and concrete aggregates were mainly supplied from a single quarry identified as Louvoulou (Kouilou). The sand used for the Xbloc production came from Loumé quarry.

- filter material 0.5 – 10 mm and 20 – 150 mm
- quarry run, core material 5 – 300 kg
- filter and work layer material 300 – 1000 kg
- armour stone for the toe 1 – 3 tonnes
- armour stone for the toe and the crest 3 – 6 tonnes and 6 – 8 tonnes

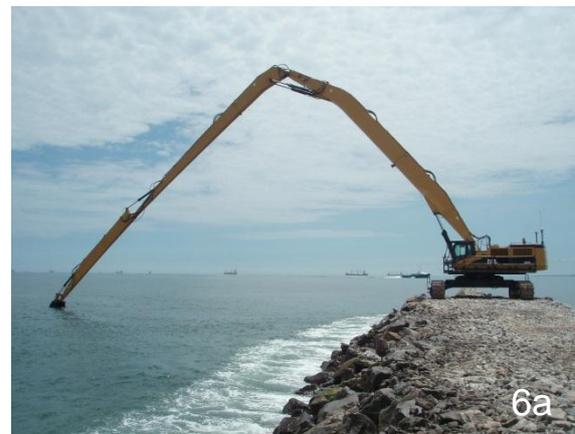
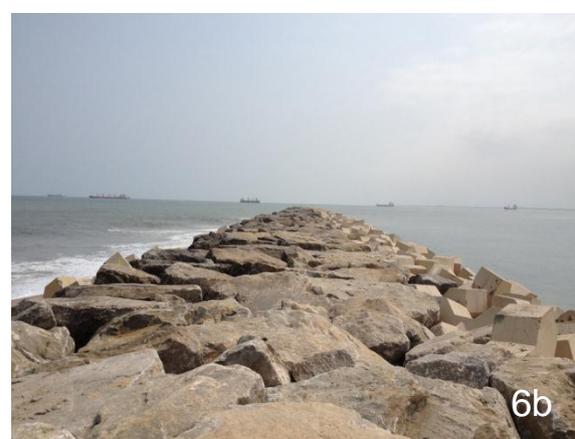
Figure 6: The Rockbuster at work (6a); completed breakwater crest (6b)

to lift 7 tonnes at a reach of 35m. The excavator was customised for the project to place the 3-6 tonnes rock toe and 9.6 tonnes Xbloc units in water depths up to 12m. The rock armour was lifted using a sling inserted into the rock which allowed the operator to place rock armour accurately along the toe. Due to the availability of the customised long boom excavator it was possible to construct the toe 20m ahead of the breakwater core and to keep clear of progressing sand (Figure 6a).

During installation the layer thickness had to be limited to 2.2m to prevent exposure of individual rocks to overtopping waves. Smaller rocks were installed in the bottom and larger rocks were subsequently installed on the top. Each rock was individually pitched and placed to ensure good interlocking and to assure a smooth crest. By careful selection and installation of each rock the layer thickness could be achieved and sufficient locking in of the Xbloc armouring was achieved in the crest. A placement production rate of 150-250 tonnes/shift was achieved. The construction of the breakwater extension was completed in June 2012. Figure 6b shows the completed breakwater crest.

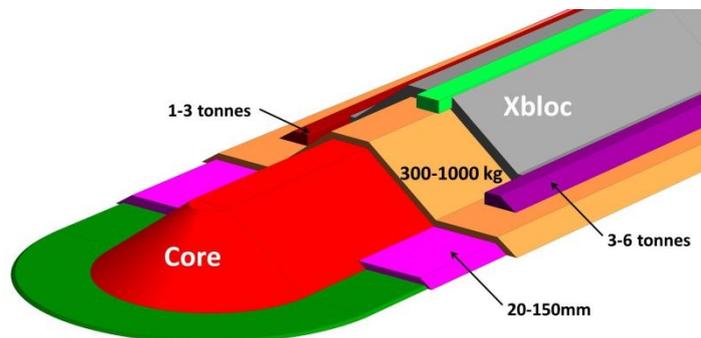
Figure 7: Breakwater model
